Re: HD #14 / OlyBond Pull Test - 4' x 8' Fiber Cement Board

# PULL TEST REPORT

REPORT NUMBER	PT-00872
TEST DATE / TIME	6/26/2018 2:30:00 PM
AMBIENT TEMPERATURE	84°F
GROUND ROUGHNESS	
TESTER MANUFACTURER	DMD Force-2000
MAX CAP OF TESTER (LBS)	2,000
TEST PERFORMED BY	Alexander Paxton
TEST CUT AREA REPAIRED BY	Tyler Elliott
TEST WITNESSED BY	Tyler Elliott

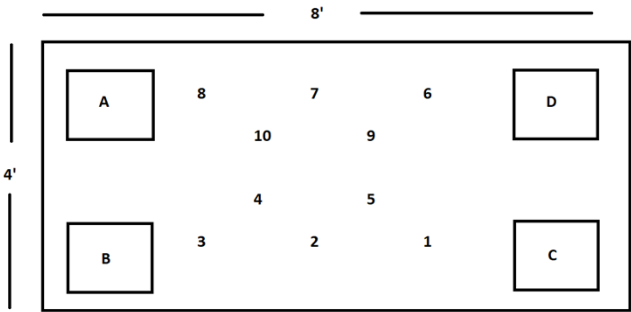
HD #14 / OLYBOND PULL TEST -  
4' X 8' FIBER CEMENT BOARD

Fastener Tests shown as 1-10  
Adhesive Tests shown as A-D

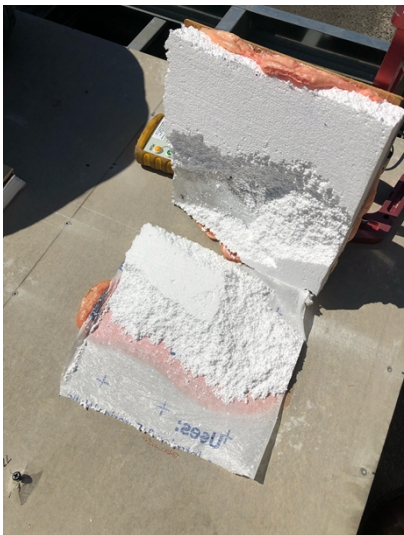
TEST LOCATION # 1

TEST LOCATION NUMBER	PULL VALUE (PSF)	FAILURE MODE	PATTERN	COMMENTS
1	450	Insulation Core Fracture	12" on center	
2	421	Insulation Core Fracture	12" on center	
3	368	Insulation Core Fracture	12" on center	
4	338	Insulation Core Fracture	12" on center
